PEOPLES AVENUE LANDFILL
SAMPLING OF WELL #1D
BY ENGINEERS INTERNATIONAL

PEOPLES AVENUE LANDFILL

1-21-88

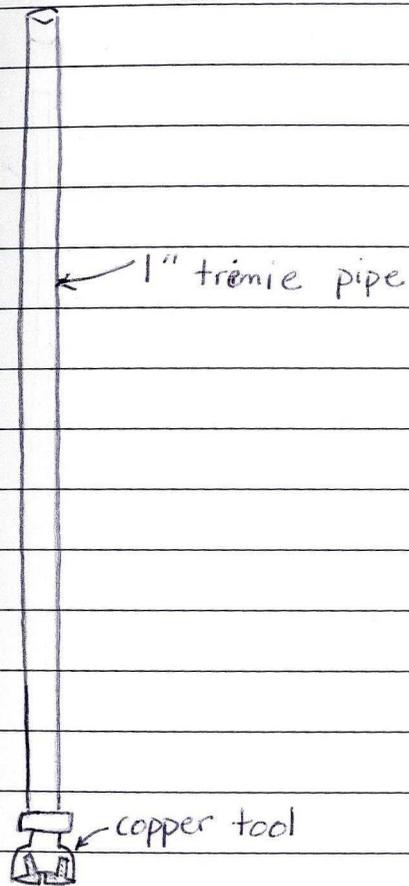
Tool used by EI to retrieve
bailer from MW-10

When the tool dropped onto the bailer
the 1st time, the force of the fall
broke the bailer. There is a large crack
at the top.

When forced onto the PVC bailer, the copper
attachment splays and grabs onto the bailer

Are using an assembly illustrated on ^{2AC} ~~text~~ page 5 to fish bailer out, 10:50 begin fishing. 11:00 dropped tool down the hole. Screwed pipe on down in hole & began pulling out. Bailer appears to be attached to tool (based on weight of assembly) Bailer is almost out of hole

12:45 EI returns. They have cut off the
damaged end of bailer & drilled holes
to string the rope through. Decon bailer.
